Resilio Studio

Kaipara District Council

Report Number: 1806

VersionPublication dateCommentsAAugust 2019Feasibility ReportBMay 2020Feasibility Report

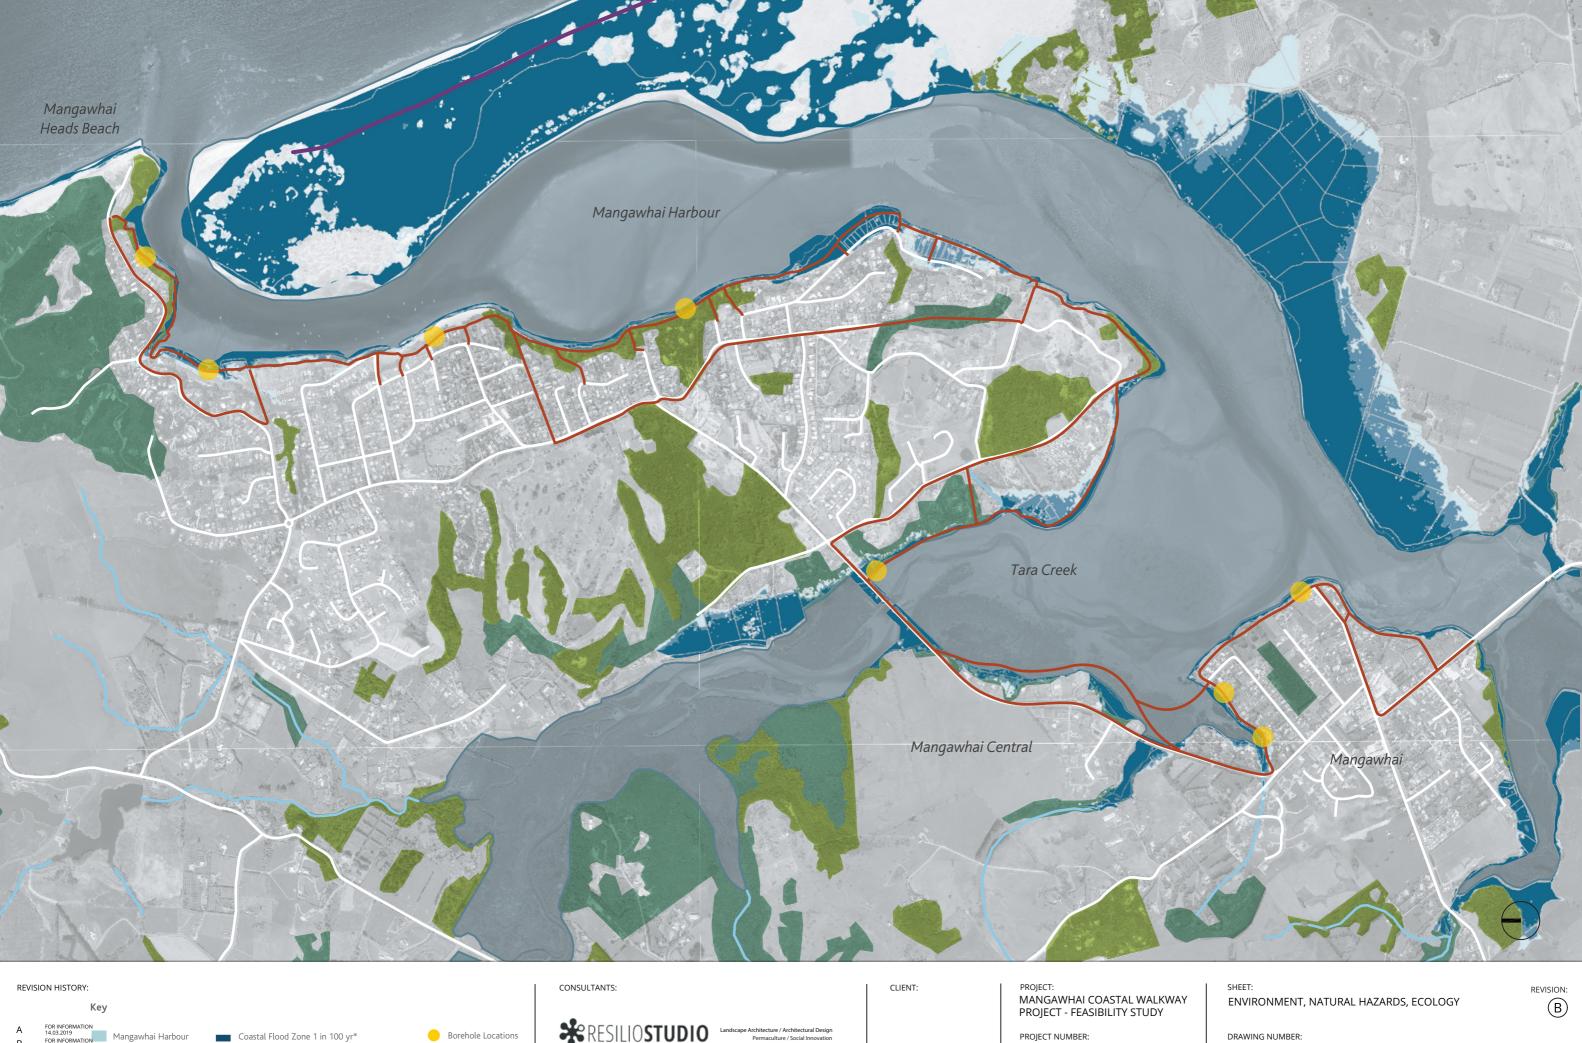
Native Vegetation Coastal Flood Zone 1 in 100 yr* Streams and Rivers Wave Run-up Zone 1 in 100 yr storm surge*

(*Measurements take into account predicted sea-level rise over the next 50-100 years)

An assessment of coastal flood hazards in Mangawhai has been undertaken by Tonkin and Taylor for the Northland Regional Council. The effects of; storm tide levels, wave run-up and sea level rise were part of the assessment. These results are indicative of a 1-50 or 100 year event. Results can be seen overleaf. Long term impact of sea level rise is not indicated. ⁷

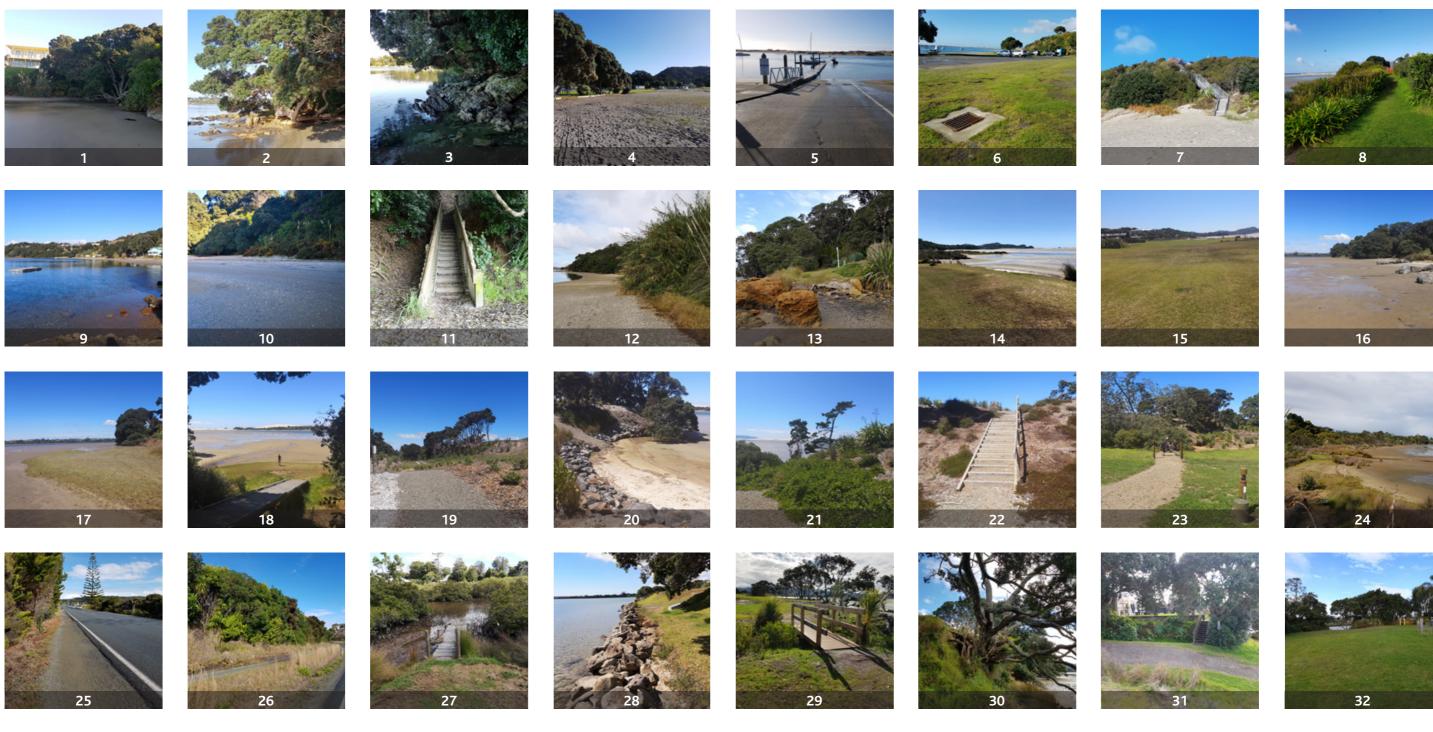
- 1. Section 1_ Sandy beach, tideline reaches edge of vegetation, overhanging pohutukawas
- 2. Section 1_ Overhanging pohutukawas with rocky and sandy ground
- Section 1_ Rocky out crop with overhanging pohutukawa
- Stage One_ Sandy beach looking north -east across to the camp-ground and Wintle St Reserve
- 5. Stage One_ Community built
- Stage One_ Drainage in Stellars Reserve with car parking and public toilet in the background
- Section 2_ Metal stair access up cliff from sand beach, stairs lead to grass walkway
- Section 2_ Grass walkway along cliff top
- Section 3_ View from rocky shoreline across the bay
- 10. Section 3_ Sandy and shell line beach, limited beach at high
- boat wharf at Alamar Crescent
- stairs leading to tracks 12. Section 3_ Shelly beach, high tide reaches native vegetation 13. Section 3 Rocks and access

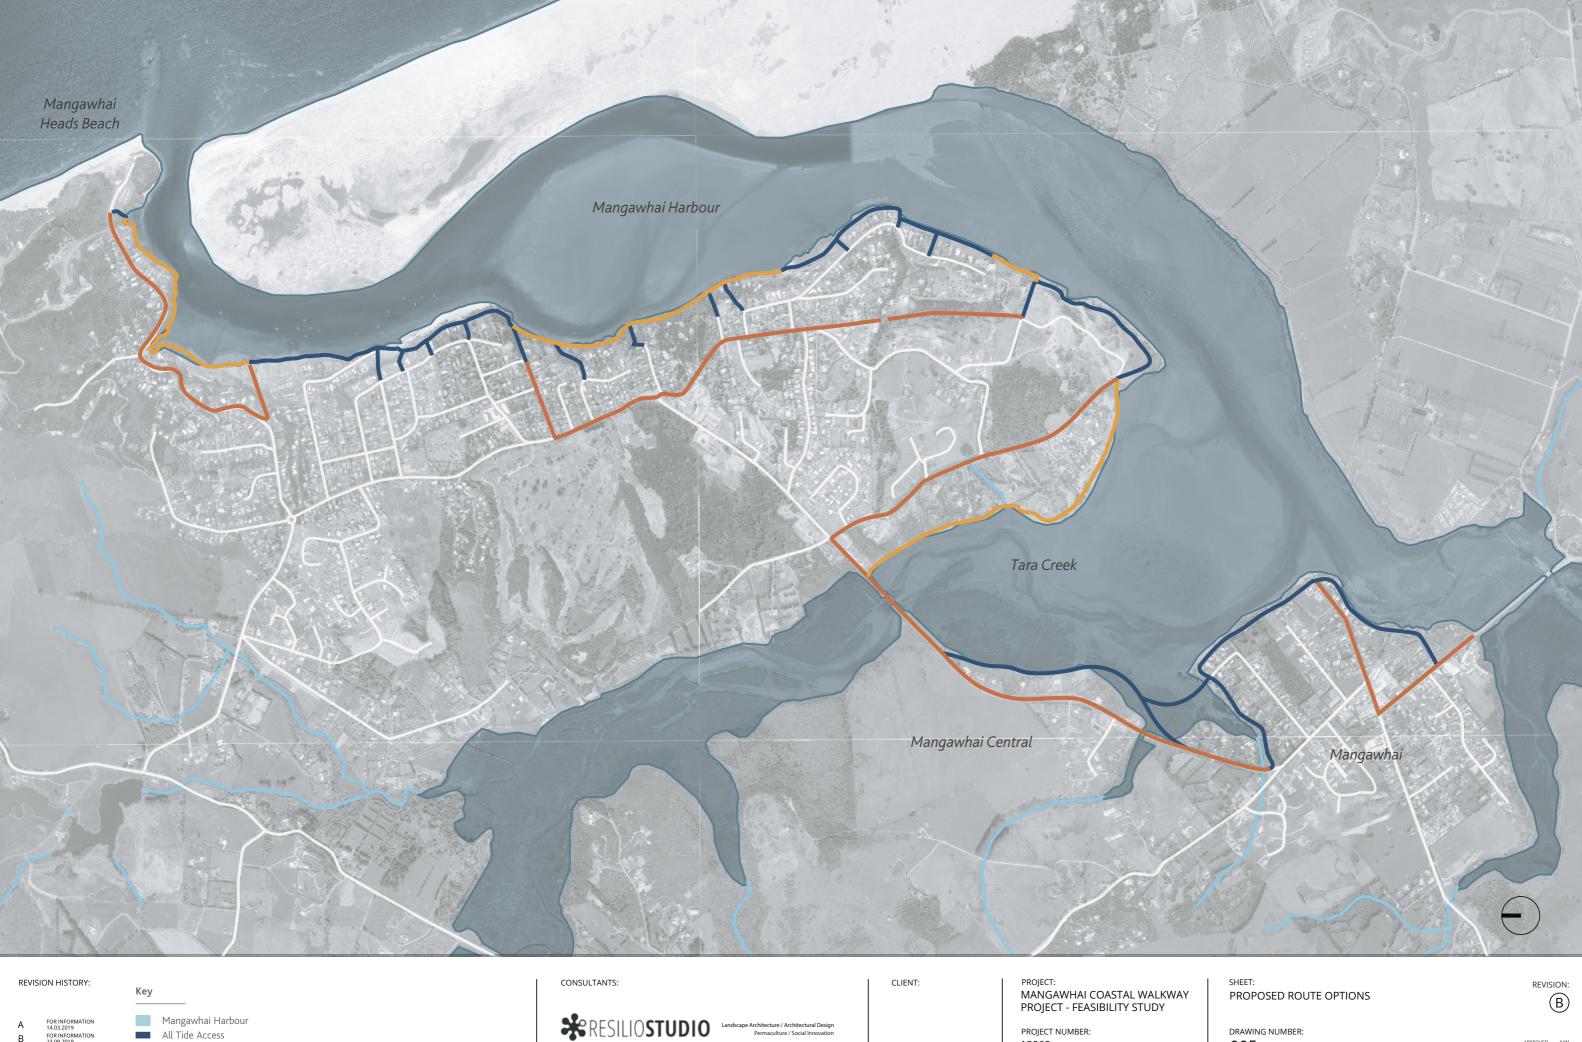
Low Tide Access Only Alternative Route

Council ownership of the proposed Mangawhai Coastal Walkway land is interrupted at several points by private land ownership. The sections of private property have been highlighted using a dotted line in Chapter 6.0_ Project Staging. In these cases, permission will need to be sought for the walkway to use the land or another option / route alignment will need to be proposed.

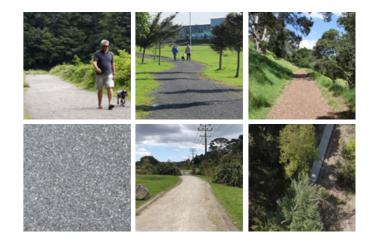
Other than slight grading, opening of sight lines and ground condition improvements, the site is left untouched in its current condition, typically either sand or grass. Improved wayfinding signage will improve connectivity in these areas and help to communicate the direction of the MCW.

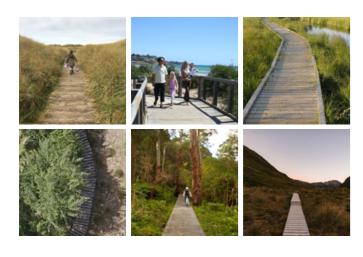
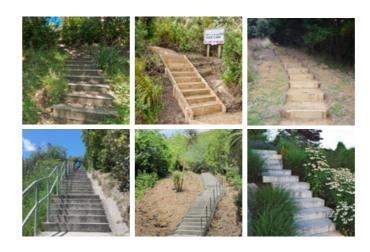
Steps

Steep gradients and significant level changes may require steps to increase accessibility and provide a safe walkway solution. Note ramped / graded solutions will be provided where possible to ensure maximum accessibility.

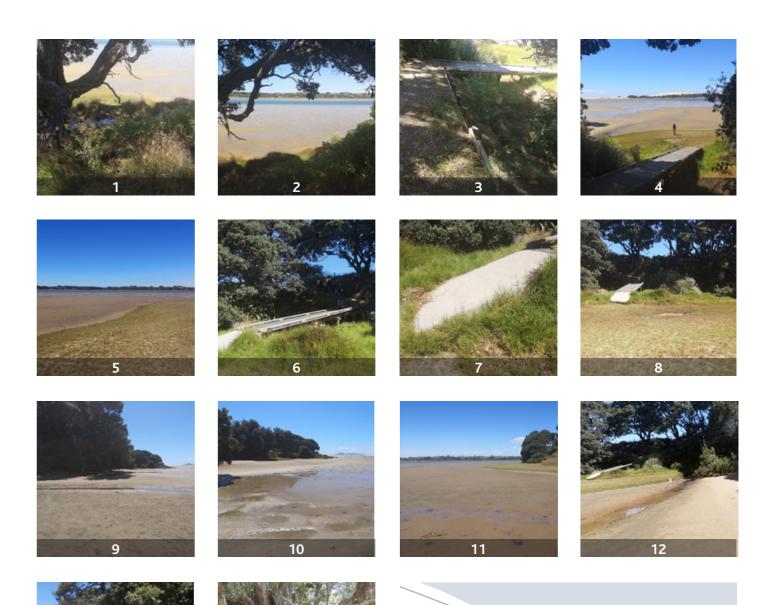
- 1. Existing vegetation
- 2. View from top of cliff across to sand dunes and houses
- . Constructed walkway down to sandflats
- 4. Bridge section down to sandflats
- 5. Sandflats with vegetation
- 6. View back up boardwalk bridge with vegetation
- 7. Concrete connection from
- bridge to sandflats 8. View from sandflats of walkway and cliff
- 9. Sandflats with overhanging pōhutukawas facing north
- 10. Photo further north of sandflats and overhanging pōhutukawas
- 11. Same as photo 9, looking south
- 12. Sandflats in the foreground with narrow stream outlet. A few mangroves are established here

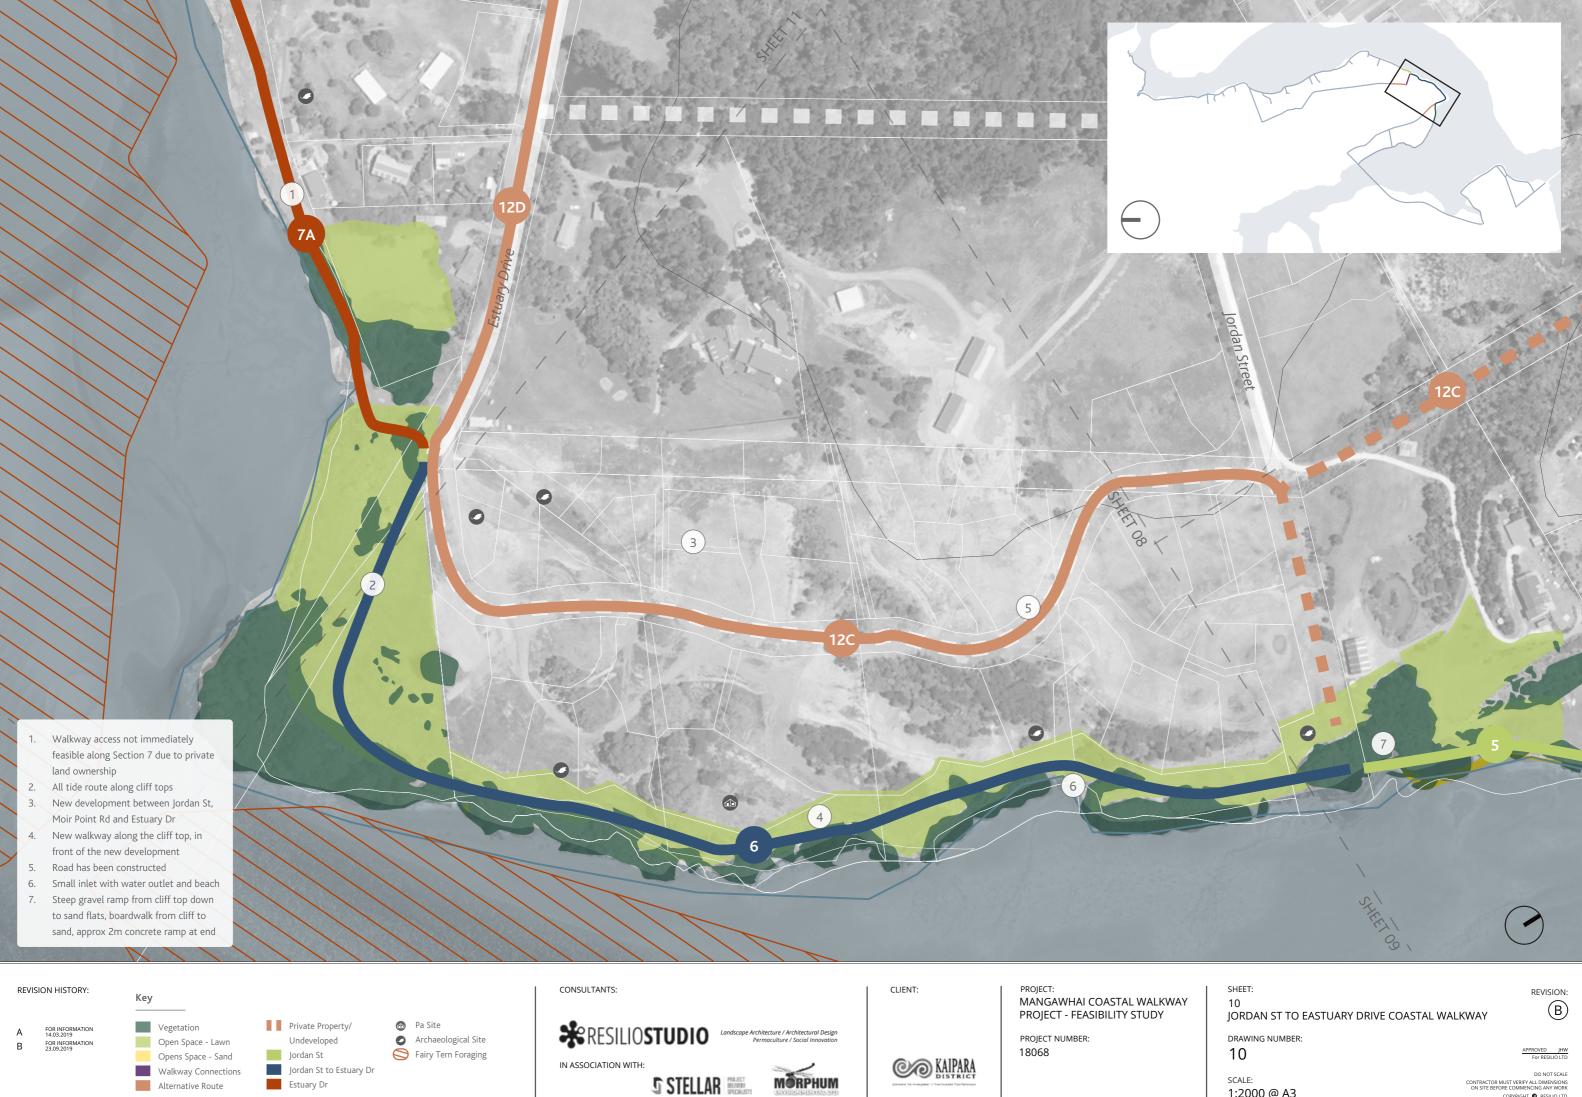
6.8_ Section 6 - Jordan St to Estuary Drive Coastal Walkway

- New gravel path implemented with new vegetation at the northern end of section six
- New gravel and coastal vegetation looking north
- Looking south from photo
 with open grass area to
 the right of the walkway potentially part of housing
 development
- 4. Small beach inlet significant planting, retaining and erosion
- 5. Gravel path to photo 4
- 6. Gravel path with more established coastal vegetation, mainly taupata
- 7. Gravel path along top of cliff with low-lying vegetation
- 8. Staircase to northern path and pa site
- 9. Walkway looking south
- 10. Walkway looking north
- 10. Walkway looking no11. Coastal vegetation
- 12. Start of walkway by Estuary
 Drive with pou whenua
- 13. Formal entrance from Estuary
 Drive with pou whenua and
 põhutukawa tree

14. Coastal walkway signpost and new road with footpath

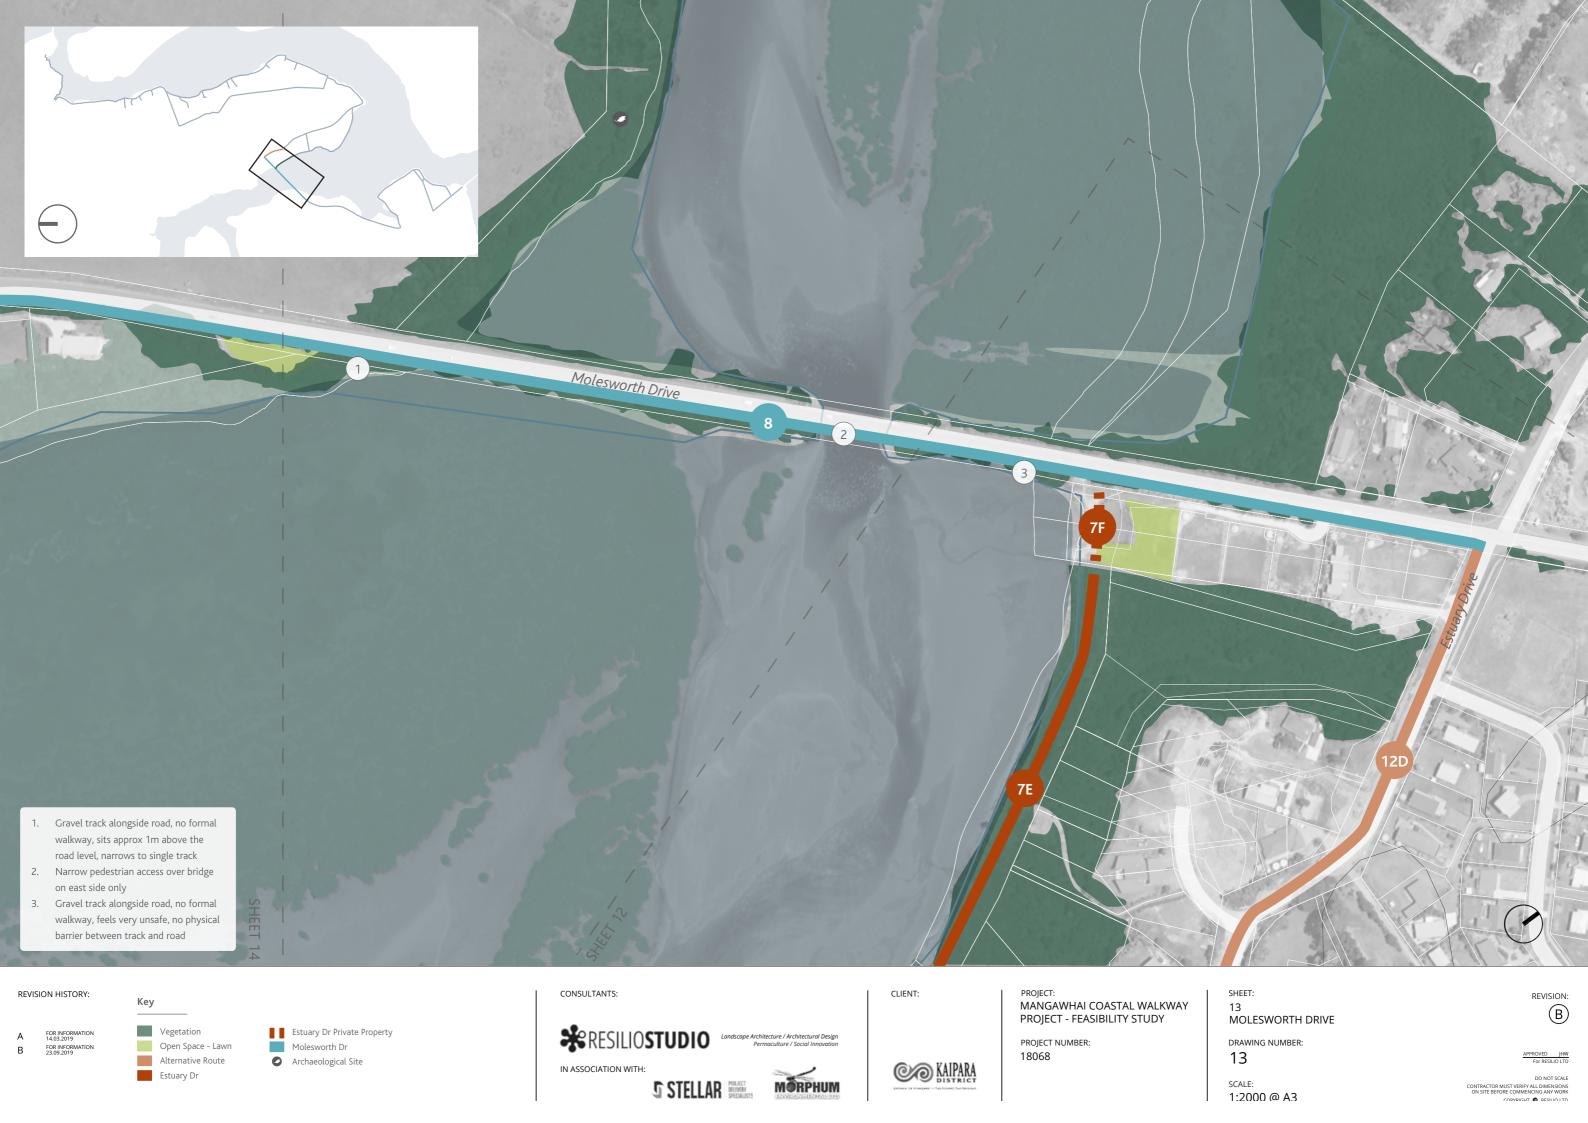
- 1. Looking south east down Molesworth Dr from Estuary Dr intersection, no walkway on either side of road
- 2. Looking south east down Molesworth Dr with informal gravel path along 80km / h
- 3. Looking north west from bridge up Molesworth Dr
- 4. Current bridge condition, narrow wooden walkway
- View from bridge across to mangroves
- Current condition along Molesworth Dr with vegetation and single gravel track, path sits approx 0.5 -1m above road
- See 6

- Photo locations are indicative only
- 9. Track narrows to a very thin 12. Track is wider and more track with road barriers and formalised, still gravel with mainly grass berm vegetation
 - 13. Gravel track begins to head Track opens up, still narrow, road barriers end into Mangawhai Village
 - 14. Track becomes an approx 1.8m concrete walkway

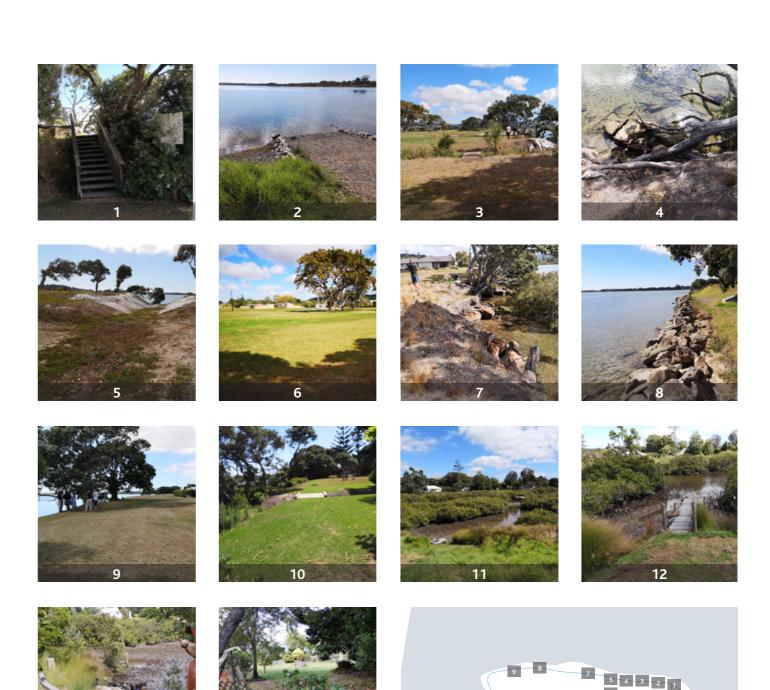
- Stair access only to walkway in front of tavern
- 2. Boat ramp access to inlet from Moir Street
- Existing wooden bridge over outlet
- Erosion and undercutting of bank
- Temporary drainage from new development site
- 6. New development site, currently grass
- Existing bank with erosion and undercutting, bank help by tree roots and rocks
- 8. Erosion control along bank, failing in places
